99-7801

INSTALLATION INSTRUCTIONS

ACURA CL 1997-99

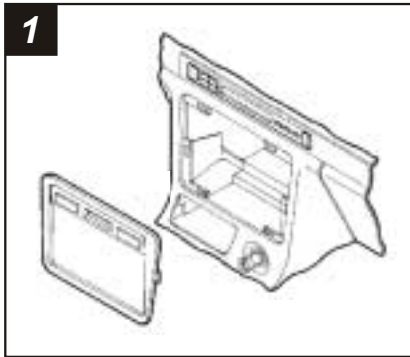
1
Disconnect the negative battery terminal to prevent an accidental short circuit. Unclip the radio trim bezel and disconnect the clock and climate control wiring. Remove (2) 8mm hex-head screws securing the factory head unit and disconnect the wiring.

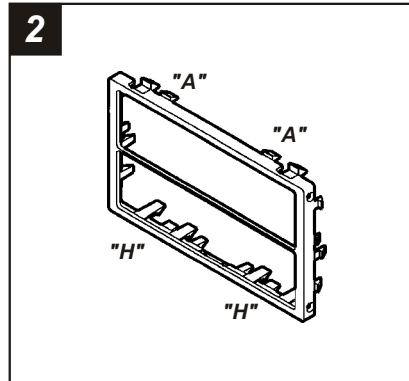
2
Cut and remove all mounting clips on the **Radio Housing** EXCEPT clips "A" and "H". Skip to step #3b on Page 10.

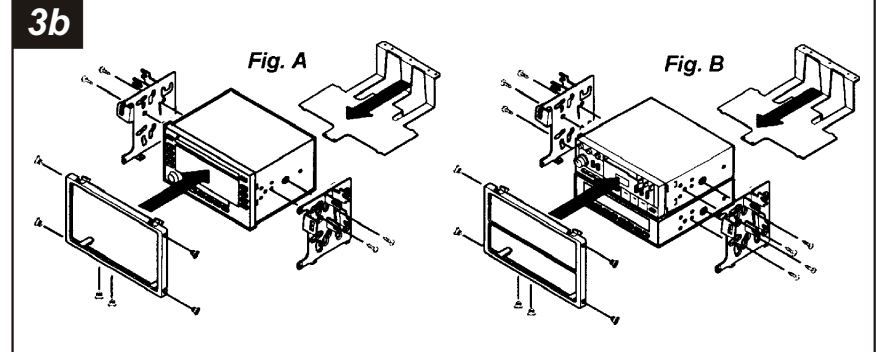
DOUBLE-DIN HEAD UNITS: Cut and remove the dividing rib from the radio opening. Cut and remove all mounting tabs on the **ISO Brackets**, align the holes in the Brackets with the holes in the head unit and secure with the screws included with the unit. Slide the **Rear Support Tray** under the unit. Position the **Radio Housing** over the unit and mount to the ISO Brackets with (4) #6 x 1/4" **Flat-head Screws** supplied and to the Rear Support Tray with (2) #6 x 1/4" **Flat-head Screws** supplied (Fig. A).

ISO STACK HEAD UNITS: Cut and remove all mounting tabs on the **ISO Brackets**, align the holes in the Brackets with the holes in the head units and secure with the screws included with the units. Slide the **Rear Support Tray** under the units. Position the **Radio Housing** over the units and mount to the ISO Brackets with (4) #6 x 1/4" **Flat-head Screws** supplied and to the Rear Support Tray with (2) #6 x 1/4" **Flat-head Screws** supplied (Fig. B).

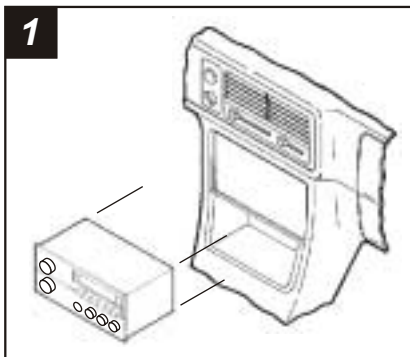
1
Disconnect the negative battery terminal to prevent an accidental short circuit. Remove (3) screws from each side of the center console and remove the console. Remove (2) screws securing the factory head unit to the sub-dash support bracket. Slide the head unit/pocket assembly out and disconnect the wiring.

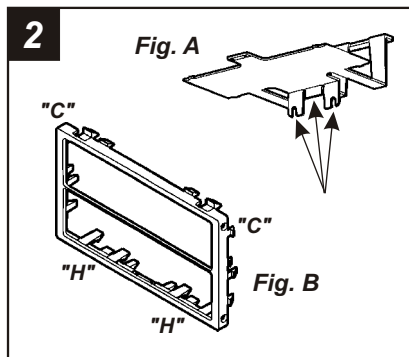
2
Cut and remove the mounting tabs from the bottom of the **Rear Support Tray** (Fig. A). Cut and remove all mounting clips on the **Radio Housing** EXCEPT clips "C" and "H" (Fig. B). Skip to step #3b on Page 10.

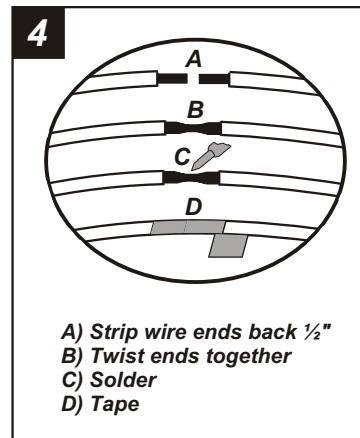
4
Locate the factory wiring harness in the dash. Metra recommends using the proper mating adaptor and making connections as shown. (Isolate and individually tape off the ends of any unused wires to prevent electrical short circuit).

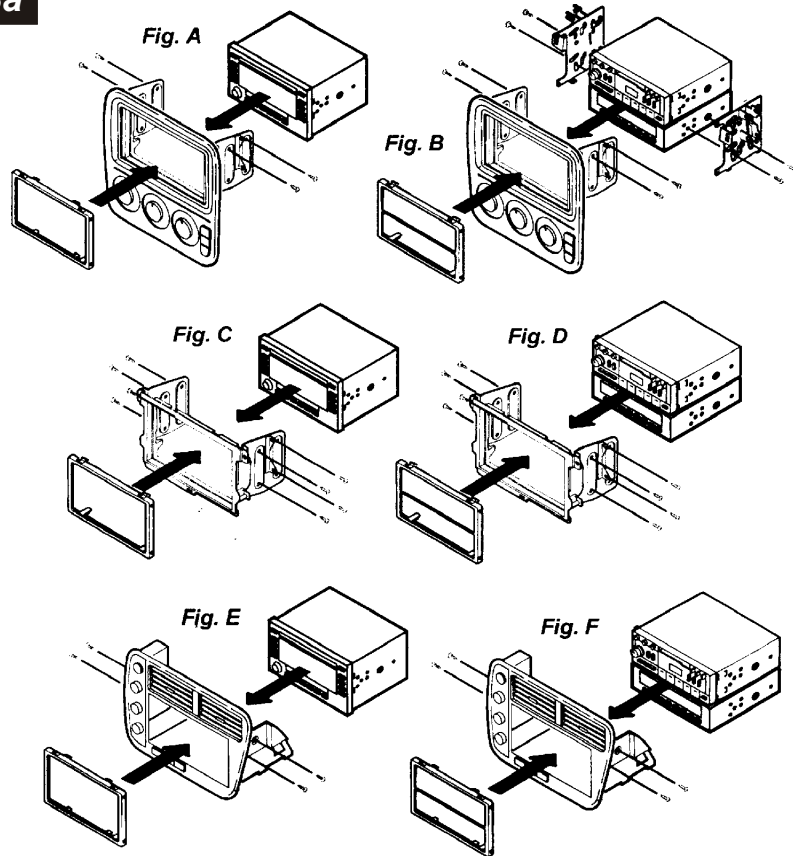
3a

CRV: DOUBLE DIN HEAD UNITS: Slide the head unit into the factory bracket assembly. Align the holes in the brackets with the holes in the head unit and secure with the screws included with the unit. Cut and remove the dividing rib from the **Radio Housing** and snap the Housing into the opening (Fig. A). Skip to step #4 on Page 10.

ISO STACK HEAD UNITS: Slide the aftermarket head unit (and digital sound processor, equalizer, etc.) into the **ISO Brackets** and mount the lower unit to the Brackets with the screws included with the unit. Slide the units into the factory bracket assembly. Align the holes in the brackets with the holes in the upper unit and secure with the screws included with the unit. Snap the Radio Housing into the radio opening (Fig. B). Skip to step #4 on Page 10.

PRELUDE 1997-01: DOUBLE DIN HEAD UNITS: Slide the head unit into the factory bracket assembly. Align the holes in the brackets with the holes in the head unit and secure with the screws included with the unit. Cut and remove the dividing rib from the **Radio Housing** and snap the Housing into the opening (Fig. C). Skip to step #4 on Page 10.

ISO STACK HEAD UNITS: Slide the aftermarket head unit (and digital sound processor, equalizer, etc.) into the factory bracket assembly. Align the holes in the brackets with the holes in the units and secure with the screws included with the units. Snap the Radio Housing into the radio opening (Fig. D). Skip to step #4 on Page 10.

CIVIC 1999-00: DOUBLE DIN HEAD UNITS: Slide the head unit into the factory bracket assembly. Align the holes in the brackets with the holes in the head unit and secure with the screws included with the unit. Cut and remove the dividing rib from the **Radio Housing** and snap the Housing into the opening (Fig. E). Skip to step #4 on Page 10.

ISO STACK HEAD UNITS: Slide the aftermarket head unit (and digital sound processor, equalizer, etc.) into the factory bracket assembly. Align the holes in the brackets with the holes in the units and secure with the screws included with the units. Snap the Radio Housing into the radio opening (Fig. F). Skip to step #4 on Page 10.

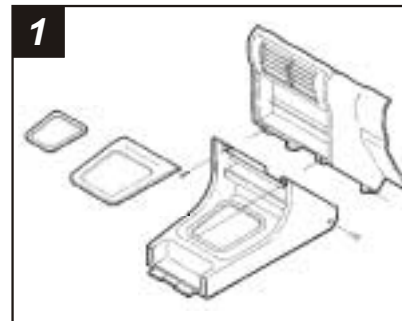
1
Disconnect the negative battery terminal to prevent an accidental short circuit. Remove the cover cap located under the emergency brake and remove (2) screws exposed. Remove (2) screws from the rear corners of the lower dash trim bezel and remove. Remove the ashtray and (2) screws exposed. Unsnap the ashtray housing and disconnect the cigarette lighter harness. Remove the gear shifter knob and unsnap the shifter trim. Remove (2) screws below the radio opening and remove the upper dash trim bezel. Remove (2) 8mm screws securing the factory head unit and disconnect the wiring.

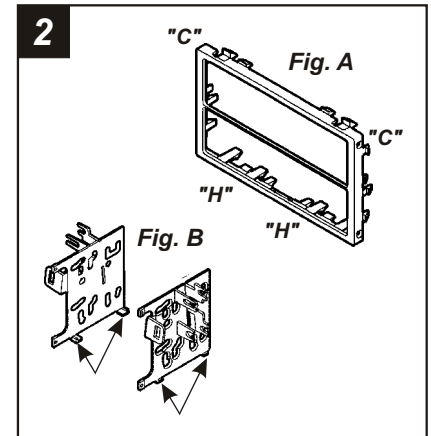
2
Cut and remove all mounting clips on the **Radio Housing** EXCEPT clips "C" and "H" (Fig. A). Cut and remove the slots on the bottom of the **ISO Brackets** (Fig. B). (**THE REAR SUPPORT TRAY WILL NOT BE USED**). Skip to step #3b on Page 10.

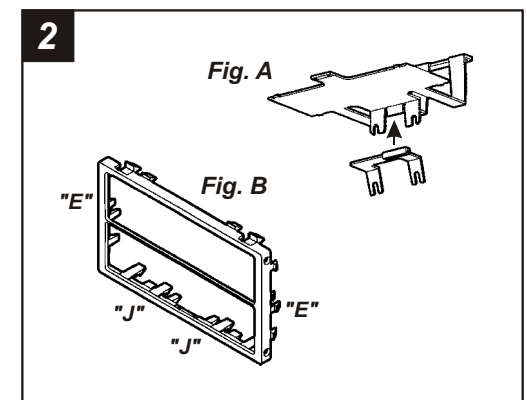
2
Attach the **Mounting Bracket** to the bottom of the **Rear Support Tray** (Fig. A). Cut and remove all mounting clips on the **Radio Housing** EXCEPT clips "E" and "J" (Fig. B). Skip to step #3b on Page 10.

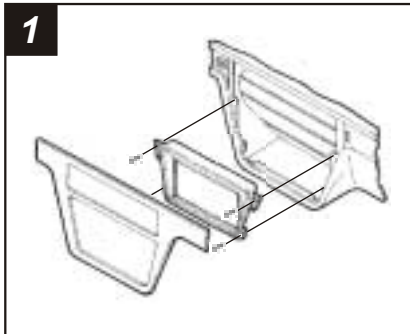
Disconnect the negative battery terminal to prevent an accidental short circuit. Using a small screwdriver, unclip the perimeter of the radio trim bezel. Disconnect the climate control and rear defroster wiring and remove the bezel. Remove (4) Phillips screws securing the factory head unit/trim bezel assembly. Loosen (2) Phillips screws securing the back of the head unit to the metal housing and slide the unit out. (It is NOT necessary to remove the screws securing the metal housing to the bezel). Disconnect the wiring.

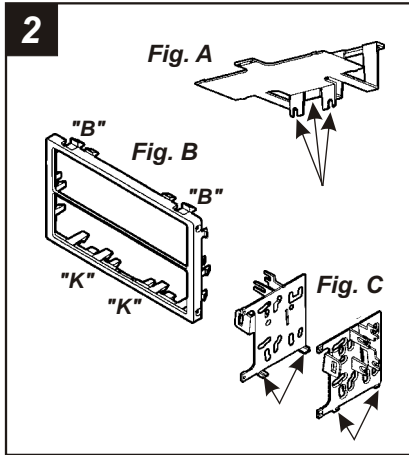
Cut and remove the mounting tabs from the bottom of the **Rear Support Tray** (Fig. A). Cut and remove all mounting clips on the **Radio Housing** EXCEPT clips "B" and "K" (Fig. B). Cut and remove the slots on the bottom of the **ISO Brackets** (Fig. C). Skip to step #3b on Page 10.

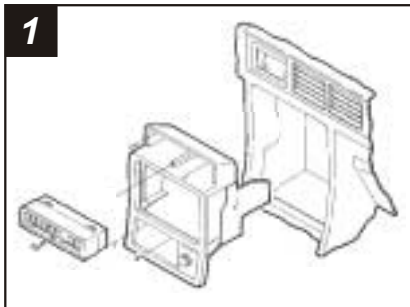
Disconnect the negative battery terminal to prevent an accidental short circuit. Remove the access cap from the climate control cluster and (1) screw exposed. Unclip the cluster and remove (2) screws exposed. Remove the ashtray and (2) Phillips screws exposed. Remove the cover caps from each front corner of the center console and the screws exposed. Open the storage compartment, lift up the carpet and remove (2) screws exposed. Lift up on the center console and remove. Unclip the radio trim bezel and disconnect the wiring. Remove (2) bolts from the back of the factory head unit and disconnect the wiring.

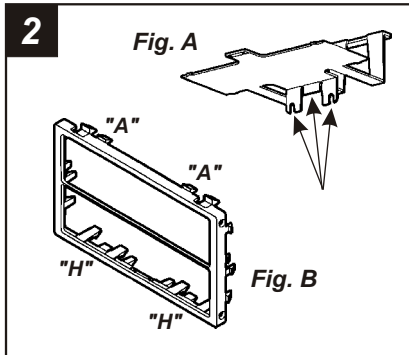
Cut and remove the mounting tabs from the bottom of the **Rear Support Tray** (Fig. A). Cut and remove all mounting clips on the **Radio Housing** EXCEPT clips "A" and "H" (Fig. B). Skip to step #3b on Page 10.

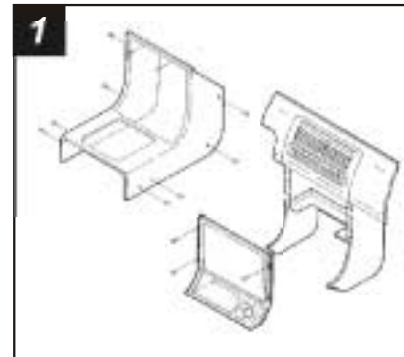
Disconnect the negative battery terminal to prevent an accidental short circuit. Remove (2) screws from the top of the console trim bezel. Slide the front seats back and remove (4) Phillips screws from each side of the bezel. Pull up on the console trim bezel and remove. Using an angled screwdriver, remove (2) screws securing the gear shifter bracket to the bezel. Remove (4) screws from the radio trim bezel, remove the factory head unit assembly and disconnect the wiring.

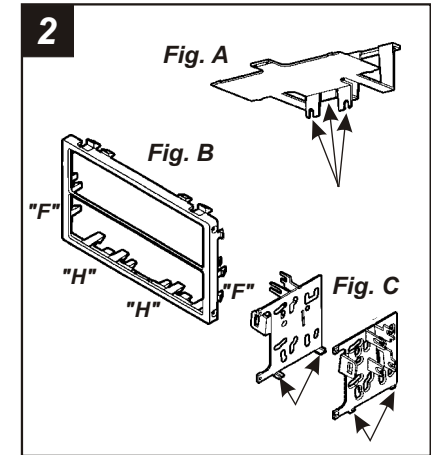
Cut and remove the mounting tabs from the bottom of the **Rear Support Tray** (Fig. A). Cut and remove all mounting clips on the **Radio Housing** EXCEPT clips "F" and "H" (Fig. B). Cut and remove the slots on the bottom of the **ISO Brackets** (Fig. C). Skip to step #3b on Page 10.

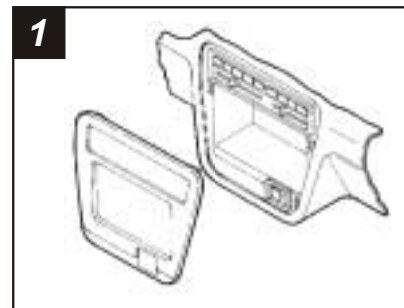
Disconnect the negative battery terminal to prevent an accidental short circuit. Using a panel removal tool, unclip the radio trim bezel and remove (some force may be required). Remove (4) Phillips screws securing the factory head unit/bracket housing assembly and disconnect the wiring. Remove (4) Phillips screws securing the factory head unit to the bracket housing and remove.

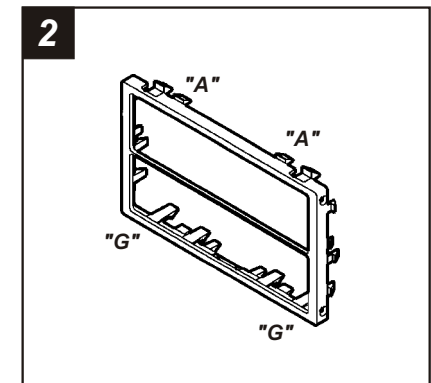
Cut and remove all mounting clips on the **Radio Housing** EXCEPT clips "A" and "G". Skip to step #3a on Page 9.

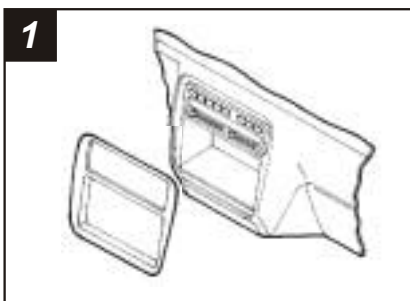
1
Disconnect the negative battery terminal to prevent an accidental short circuit. Lower the glove box assembly. Remove (2) Phillips screws exposed on the right side of the underdash. Remove (2) Phillips screws from the driver's side knee bolster and (1) Phillips screw in the coin pocket. Remove (5) Phillips screws from the underdash panel and remove the panel. Remove (4) Phillips screws from the cupholder assembly and remove. Remove (2) Phillips screws securing the factory head unit and disconnect the wiring.

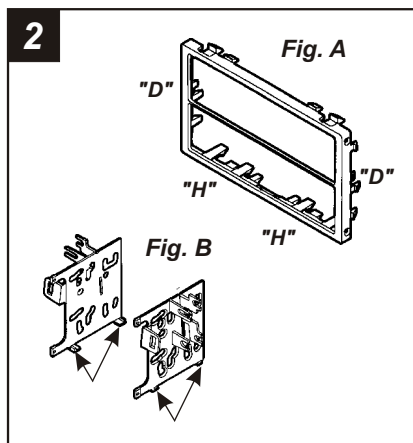
2
Cut and remove all mounting clips on the **Radio Housing** EXCEPT clips "D" and "H" (Fig. A). Cut and remove the slots on the bottom of the **ISO Brackets** (Fig. B). (**THE REAR SUPPORT TRAY WILL NOT BE USED**). Skip to step #3b on Page 10.

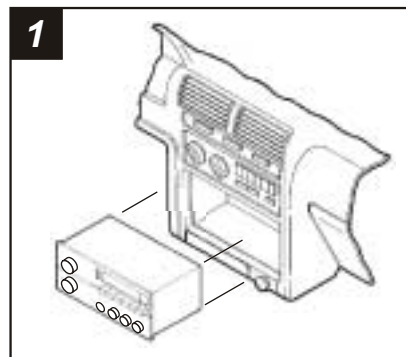
1
Disconnect the negative battery terminal to prevent an accidental short circuit. Remove (4) screws from the lower portion of the center console. Remove the gear shifter knob and lift the console out. Remove the ashtray and ashtray bracket. Remove (2) screws from the bottom of the head unit support, slide the unit out and disconnect the wiring.

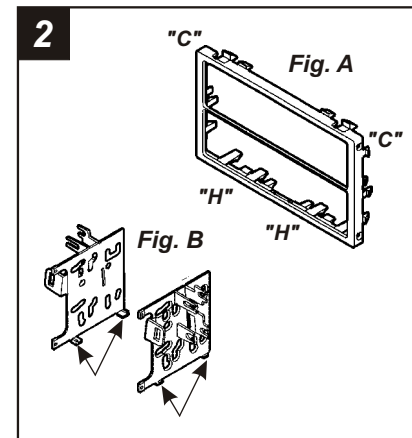
2
Cut and remove all mounting clips on the **Radio Housing** EXCEPT clips "C" and "H" (Fig. A). Cut and remove the slots on the bottom of the **ISO Brackets** (Fig. B). (**THE REAR SUPPORT TRAY WILL NOT BE USED**). Skip to step #3b on Page 10.

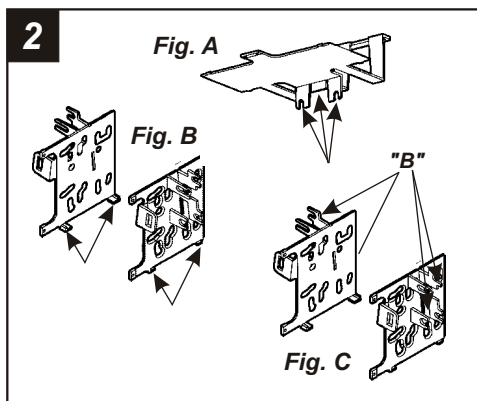
2
Cut and remove the mounting tabs from the bottom of the **Rear Support Tray** (Fig. A). Cut and remove the slots on the bottom of the **ISO Brackets** (Fig. B). Locate tabs "B" on the ISO Brackets for mounting, cut and remove tabs "A" (Fig. C). Cut and remove all mounting clips on the **Radio Housing**. Skip to step #3b on Page 10.

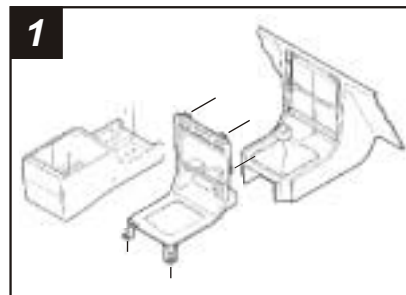
1
Disconnect the negative battery terminal to prevent an accidental short circuit. Remove the ashtray and (1) 3/4" #8 Phillips screw exposed. Open the storage compartment and remove (2) #8 Phillips screws exposed. Remove the cupholder tray and (3) #8 Phillips screws inside. Lift the center console out and remove (2) Phillips screws exposed at the base of the dash trim bezel. Unclip the bezel and remove. Remove (2) hex-head screws securing the factory head unit and disconnect the wiring.

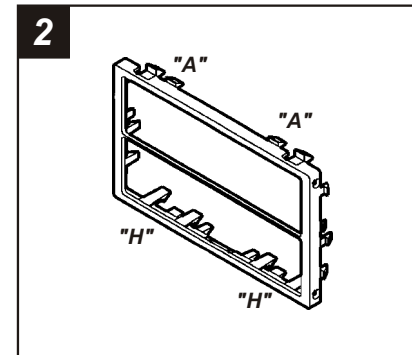
2
Cut and remove all mounting clips on the **Radio Housing** EXCEPT clips "A" and "H". Skip to step #3b on Page 10.

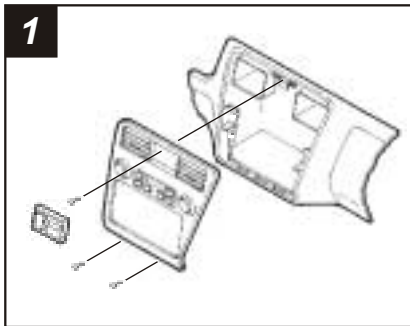
Disconnect the negative battery terminal to prevent an accidental short circuit. Unsnap the clock panel, disconnect the wiring and remove. Remove (1) Phillips screw exposed in the clock cavity. Remove (2) Phillips screws below the factory head unit. Unclip the radio trim bezel and disconnect the wiring. Remove (4) Phillips screws securing the factory head unit assembly and disconnect the wiring. Remove (2) screws securing the factory pocket to the assembly.

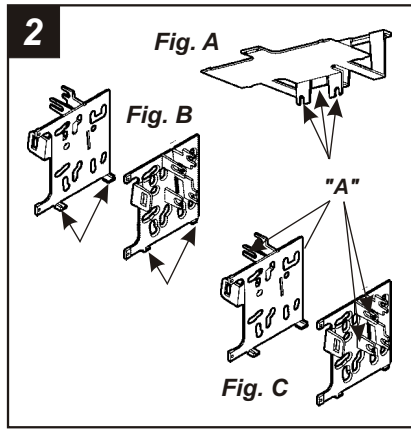
Cut and remove the mounting tabs from the bottom of the **Rear Support Tray** (Fig. A). Cut and remove the slots on the bottom of the **ISO Brackets** (Fig. B). Locate tabs "A" on the ISO Brackets for mounting, cut and remove tabs "B" (Fig. C). Cut and remove all mounting clips on the **Radio Housing**. Skip to step #3b on Page 10.

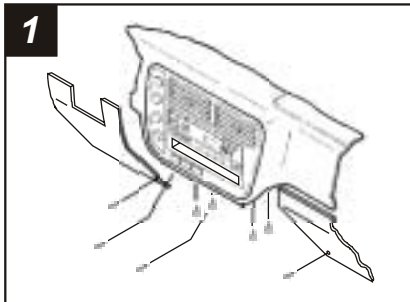
Disconnect the negative battery terminal to prevent an accidental short circuit. Remove (2) Phillips screws from the bottom edge of the glove box door and remove the door. Remove (3) Phillips screws from the lower steering column panel. Pull straight down on the lower steering column panel and remove the panel. Remove (2) Phillips screws under the climate controls. Remove (4) Phillips screws from the lower dash location. Remove (4) Phillips screws securing the bottom of the dash trim bezel/head unit assembly and pull the assembly out as far as possible. Cut the zip ties securing the head unit and climate control wires, slide the dash trim bezel/head unit assembly from the dash cavity and disconnect the wiring.

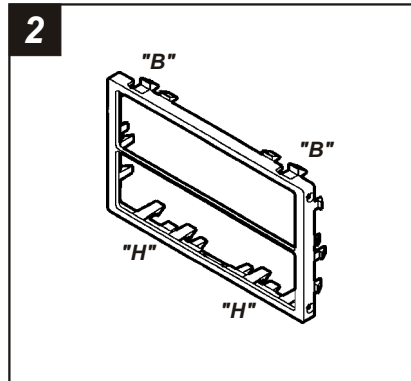
Cut and remove all mounting clips on the **Radio Housing** EXCEPT clips "B" and "H". Skip to step #3a on Page 9.

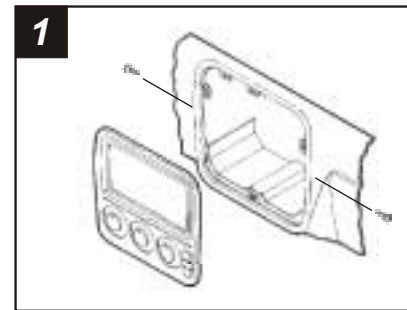
Disconnect the negative battery terminal to prevent an accidental short circuit. Open the glove box, squeeze the retaining clips and remove the stoppers. Lower the glove box and remove (2) Phillips screws from the left edge. Remove (2) Phillips screws from the lower steering column panel and remove. Unclip the lower console cover (below the ashtray and pocket) and remove. Remove (2) Phillips screws from the base of the center console, open the console cover (below the ashtray and pocket) and remove the (4) outer screws exposed. Unclip the center console and remove. Remove (2) Phillips screws securing the radio trim bezel, disconnect the wiring, and remove the trim bezel/head unit assembly. Remove (4) Phillips screws securing the head unit to the bezel and remove.

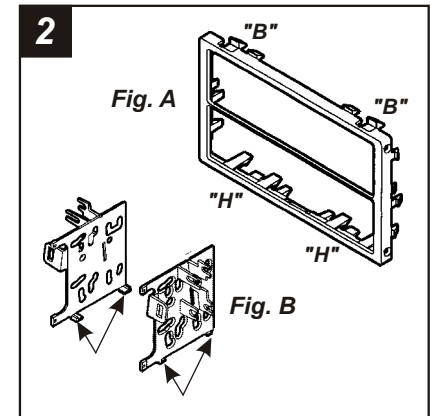
Cut and remove all mounting clips on the **Radio Housing** EXCEPT clips "B" and "H" (Fig. A). Cut and remove the slots on the bottom of the **ISO Brackets** (Fig. B). Skip to step #3a on Page 9.

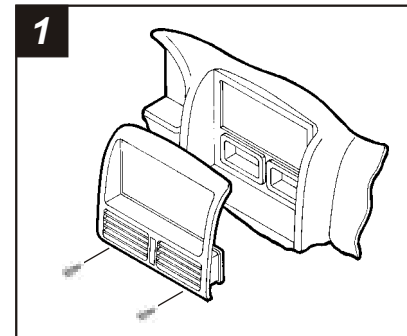
Disconnect the negative battery terminal to prevent an accidental short circuit. Remove (2) Phillips from the bottom edge of the radio trim bezel. Unclip the trim bezel and remove. Remove (4) Phillips screws securing the factory head unit and disconnect the wiring.

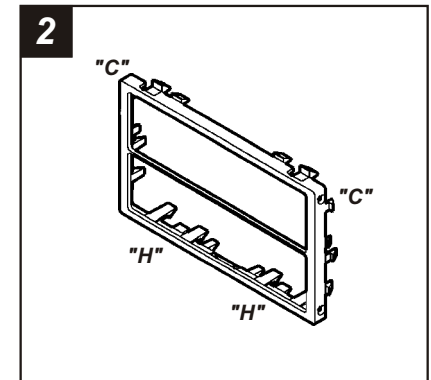
Cut and remove all mounting clips on the **Radio Housing** EXCEPT clips "C" and "H". Skip to step #3a on Page 9.
